Vertex

Onsite Trouble Shooting Guide

Application Note

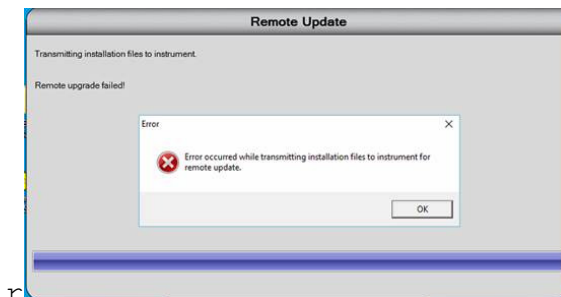
There is another issue with Windows 10, the remote upgrade failed due to transmitting file error, remote upgrade cannot be supported with Windows 10 PC.

Remote firmware upgrade is not supported with Windows 10 Operation system.

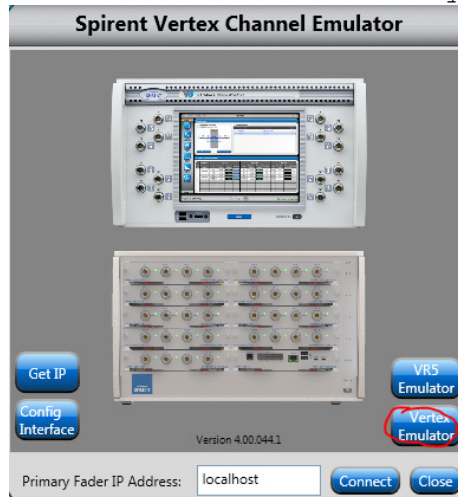
It will take about 20 second to run start Vertex Emulator after you click the button. Then you can connect to localhost

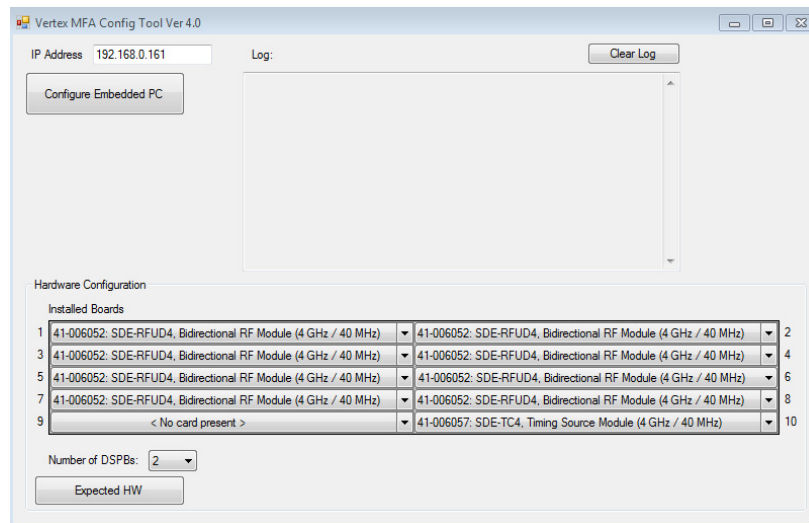
- Run the MFAPCConfiguration.exe from the path:
C:\Program Files(x86)\Spirent Communications\Vertex

- Then select right RF module at the slot installed and how many DSPs are installed, the DSP board installation sequence is from up to down.
- Click **“Expected HW”** to implement.
- Close the application

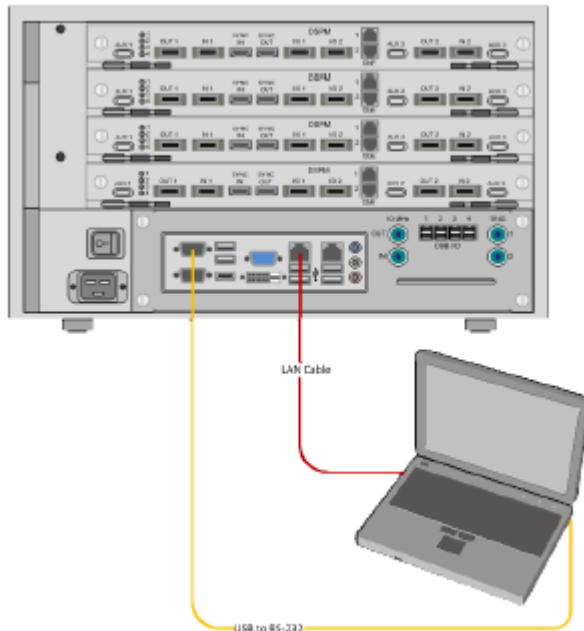
The User Ethernet port is the left one , and RS-232 cable should be connect to the upper port.

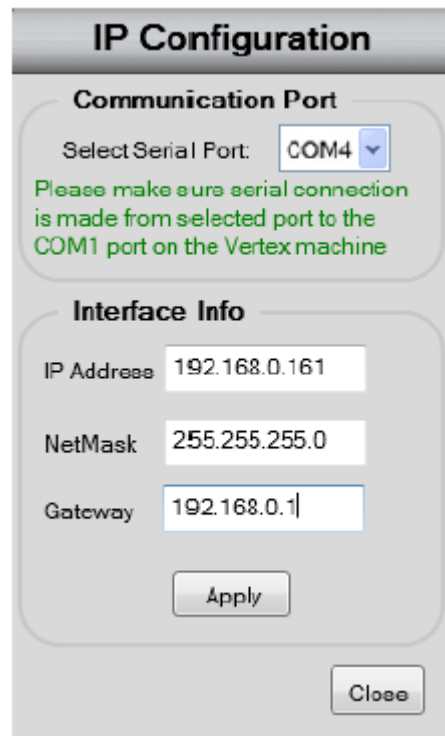
On Vertex GUI, select the serial port as set in device manager.

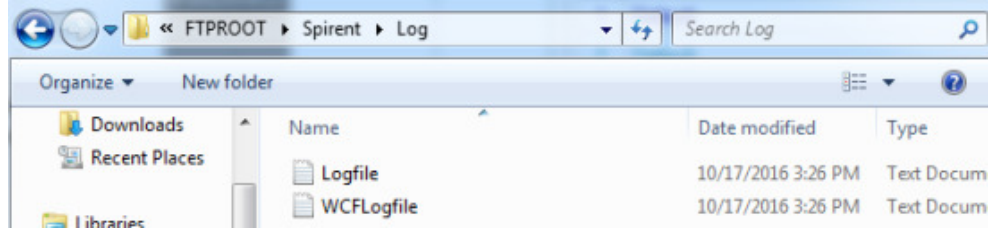
- Navigate to D:\FTPROOT\Spirent\Log\

- Copy the Logfile.log file and WCFLlogfile.log to the USB drive.

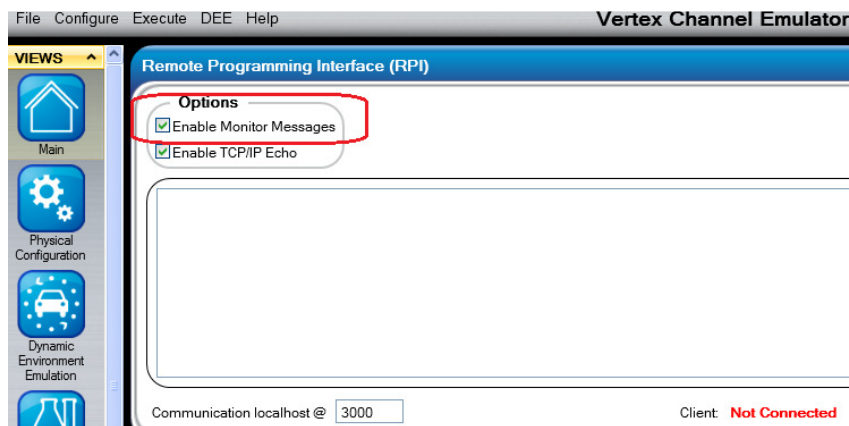
1. Enable Monitor Message at RPI control window

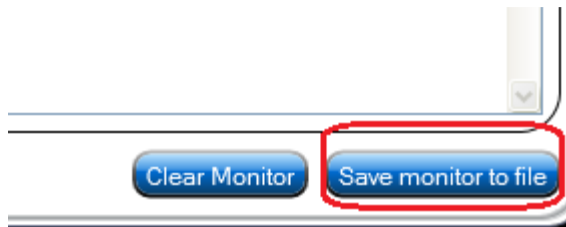
2. Run the test script, then the scripts will be displayed in the window.
3. After the script finish, save the monitor to file.
